Taking a good look: Visual data for improved pipeline integrity management decisions

Author: Michael Bruns, Sales Manager Field Products & Services, ROSEN Europe

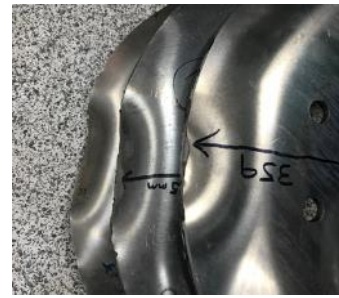
One specific application of the visual inspection device was to prove a potential restriction/obstacle in an over 50-year-old pipeline, as the sensor arms of a high-resolution geometry tool had been heavily damaged during an in-line inspection, and the gauging discs showed an unexplainable deformation (see Figure 2).

Figure 2: Gauge plates with unexplainable deformation

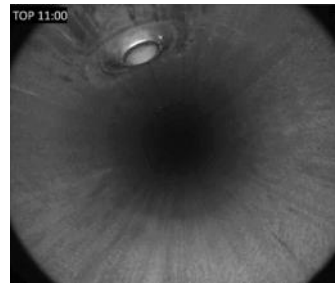
Figure 3: Protruding offtake in an over 50-year-old pipeline

The recorded RoVisual data gave a fast and clear answer - an unknown approximately 50 mm protruding offtake was the reason for these damages (see Figure 3). As a result, the operator removed these offtakes to ensure a safe and successful in-line inspection followed.
