Dent Strain and Remaining Life Assessment

Case Study

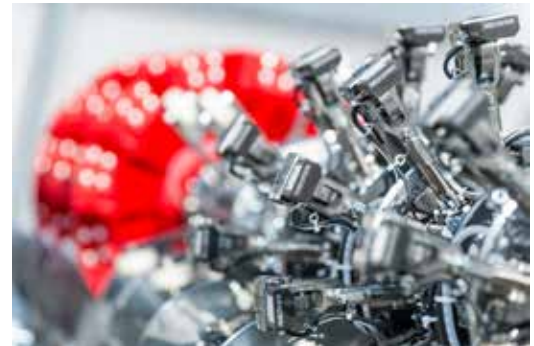
ROSEN's strain assessment demonstrated that the associated strain was less than the limit referenced in ASME B31.8. This meant that the pipeline was at a low risk of having associated cracking due to formation. Additionally, even though the dent required repair according to the API 579 / EPRG fatigue assessment, ROSEN's subsequent stress-based remaining life assessment using a level three SCF and S-N approach demonstrated that the dent would be acceptable for a further 20 years of operation.
