# Unpiggable **no more**

by Carlos Enrique Sabido and Corey Richards, Challenging Pipeline Diagnostics Division, Rosen Group, Germany

Rosen's Challenging Pipeline Diagnostics Division has, for the first time, used an MFL-equipped robotic-propulsion unit to assess the condition of a vent line that was previously considered unpiggable.

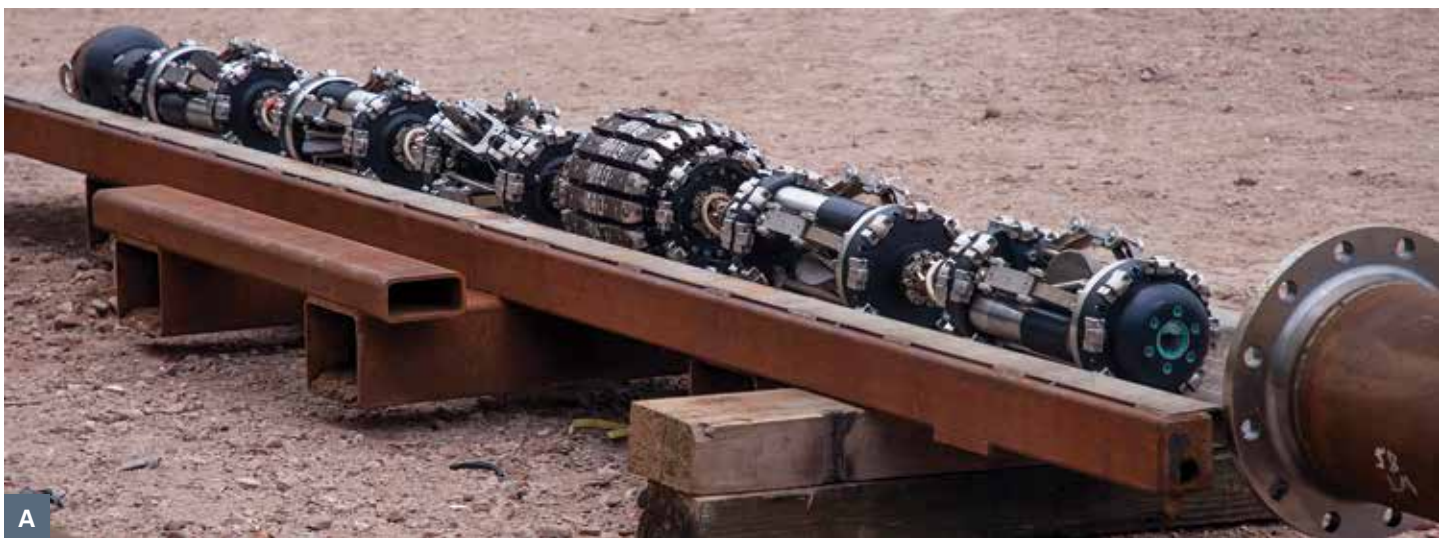
A

**A:** Robotic-propulsion unit with MFL technology (10 inch configuration without batteries).

solution that is specific to the needs and expectations of the operator regardless of the challenges associated with the pipeline. In this case, the solution included specialised-cam driving components that provide an increase in pull-force capabilities, allowing for the utilisation of extensively tested high-resolution magnetic-flux-leakage (MFL) technology.

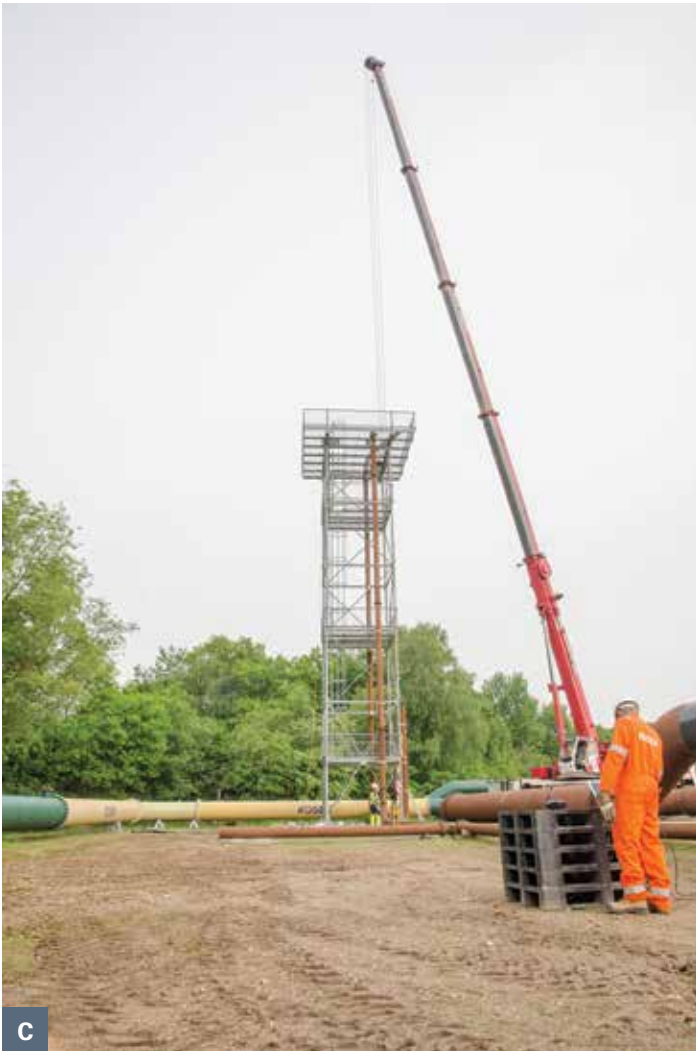
B

**B:** The configuration of the robotic-propulsion unit allowed for both vertical and horizontal bi-directional movement and distance tracking.

The design also contained both vertical and horizontal bi-directional movement capabilities and distance tracking, all of which were critical for this application. In order to confirm the tool had the capabilities to negotiate the vent line, the inspection conditions were replicated with the construction of a test tower and loop at Rosen testing grounds in Lingen, Germany.

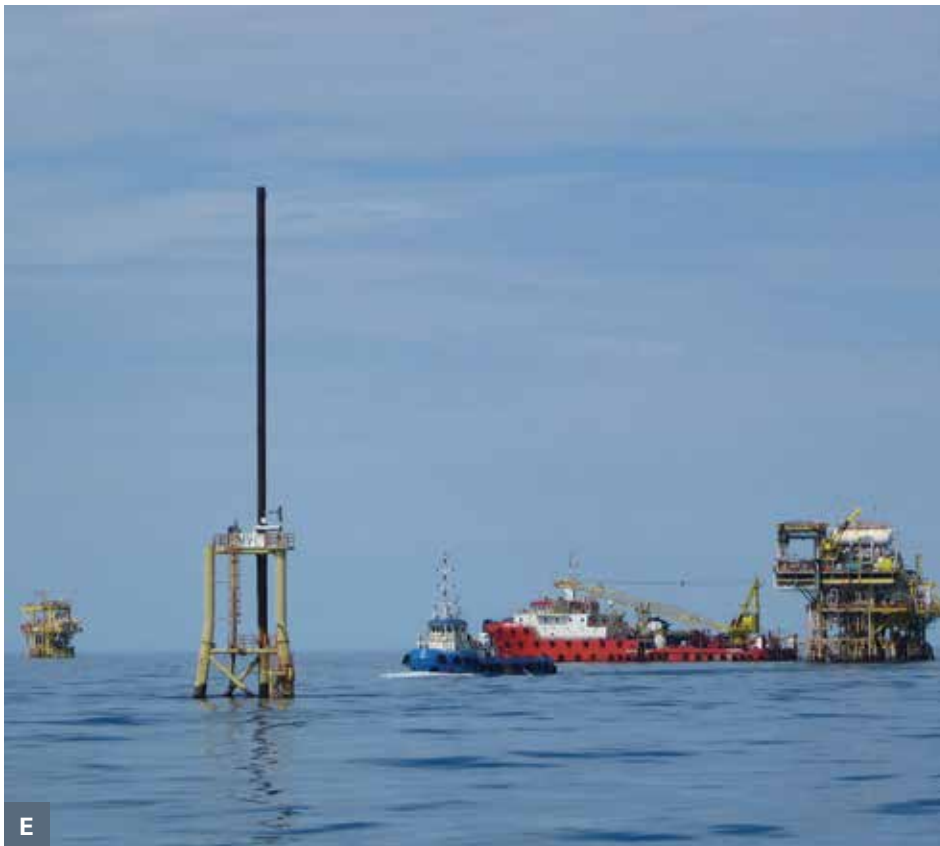
E

**E:** Vent lines reduce the risk of fire and explosion in processing systems by releasing the excessive gas at a safe distance from the platform.
