Solutions for a critical loading line lifetime extension

By Frank Mueller and Corey Richards, ROSEN Group

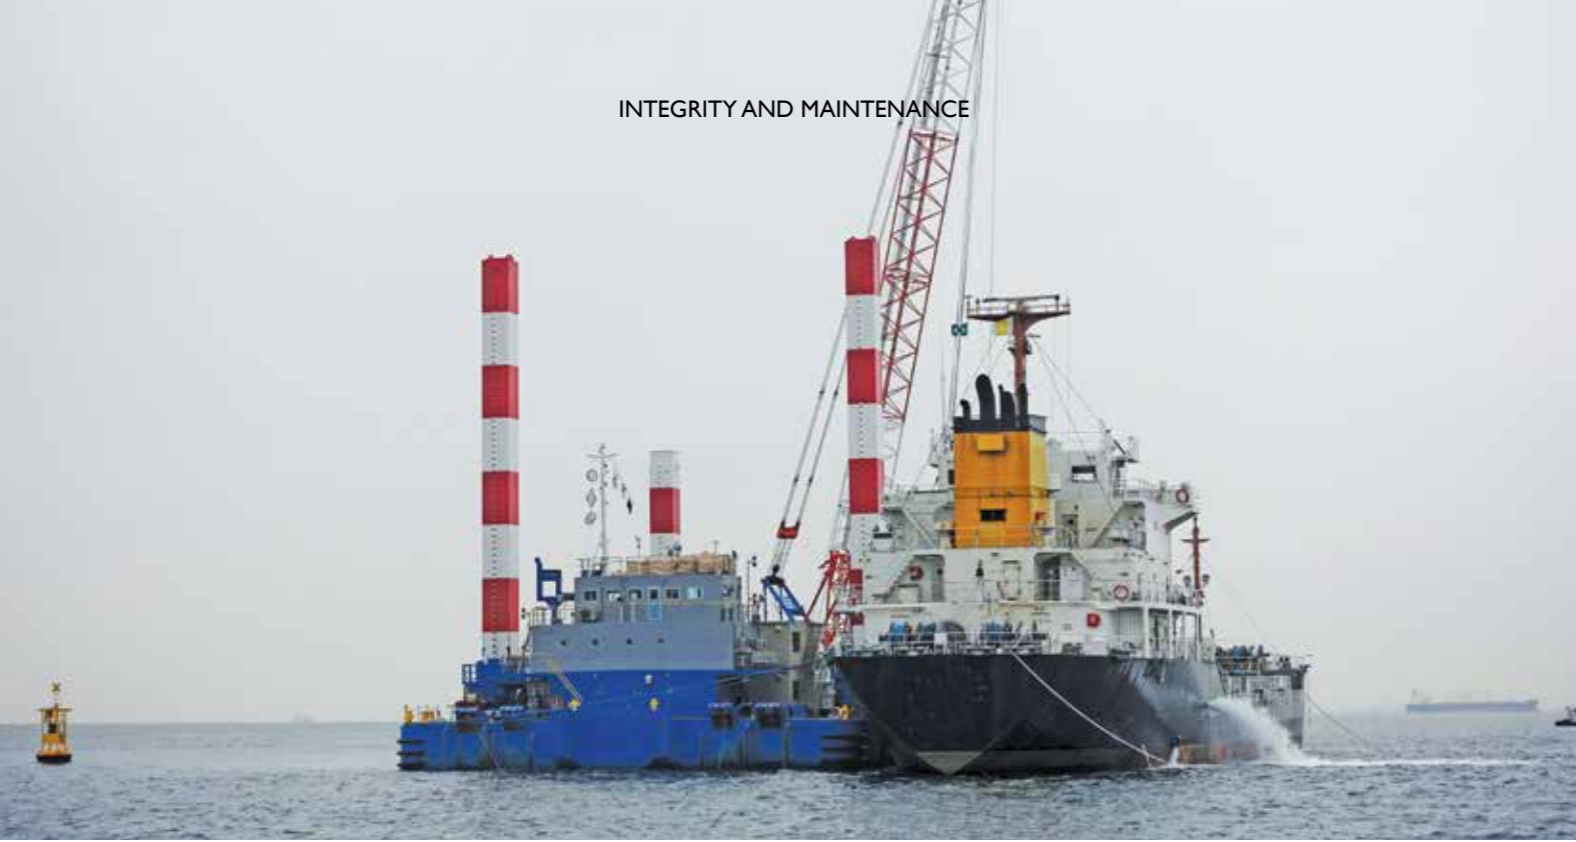
Tailored solutions are often required for the inspection of loading lines.

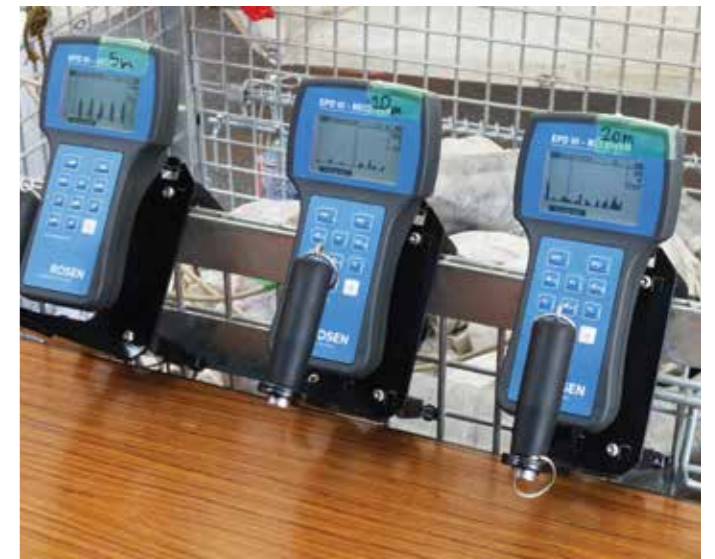
Extensive subsea monitoring systems implemented for the tracking to ensure the optimal reverse point.

As the radio frequency emitted by the transmitter unit was not strong enough to be detected above the water line, EPD antennas were positioned in predetermined intervals of 50 m, 20 m, and 10 m along the subsea line before the wye piece.

On its way towards the wye piece, the inspection tool signalled its passing at the 50 m antenna, where the pumps were slowed down to reduce the velocity to 0.2 m/s. Once it passed the 20 m antenna, the pumps were slowed further to 0.1 m/s. Finally, once the passage of the tool was detected at the antenna located 10 m from the wye, the pumps were shut down, stopping the inspection tool within 5 m of the wye piece.
