Leon de Ridder and Lewis Barton, ROSEN Group, describe how three technologies come together for corrosion detection and management of an aboveground fuel pipeline.

# THE TEAM APPROACH

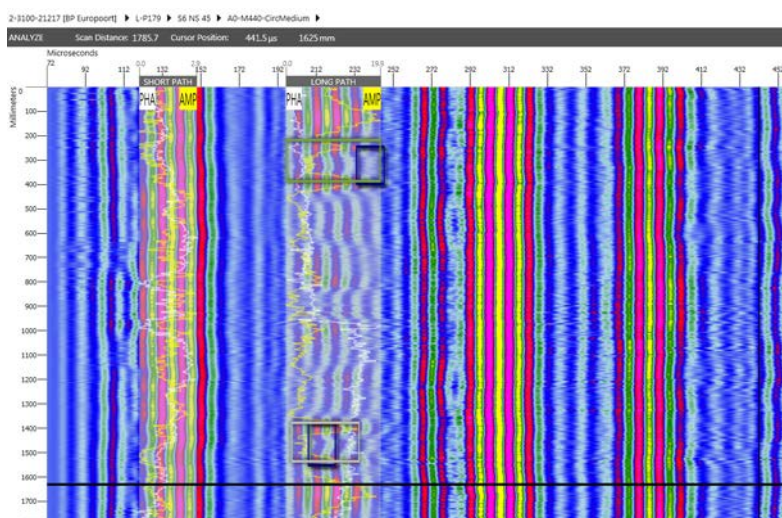
**Figure 3.** EMAT IFSE scan performed with the CIRC tool. The image shows the section with 40% wall thickness loss.

Nine supports had features with a metal loss between 40% and 59%, and for these the operator scheduled a short-term repair. In regard to the inspection of the pipe body, no features were detected (Figures 3 and 4).

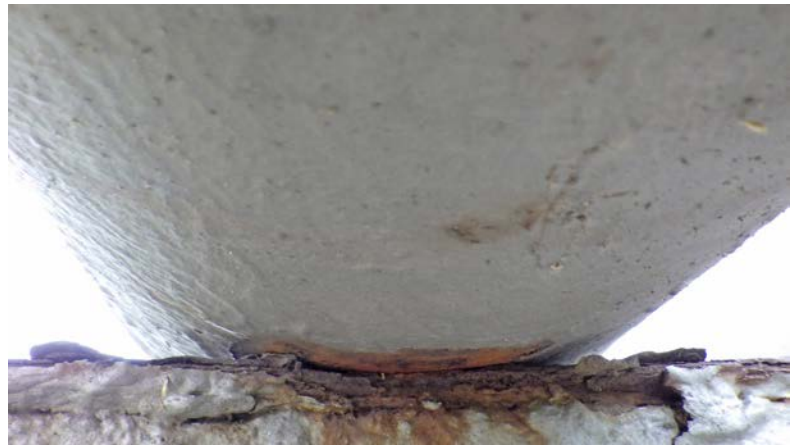
In total, 114 supports of the 8 in. pipeline were inspected. In those, 46 features with a metal loss of  $\geq 20\%$  were detected.

**Figure 4.** Image of the pipe support with 40% wall thickness loss from the exterior.

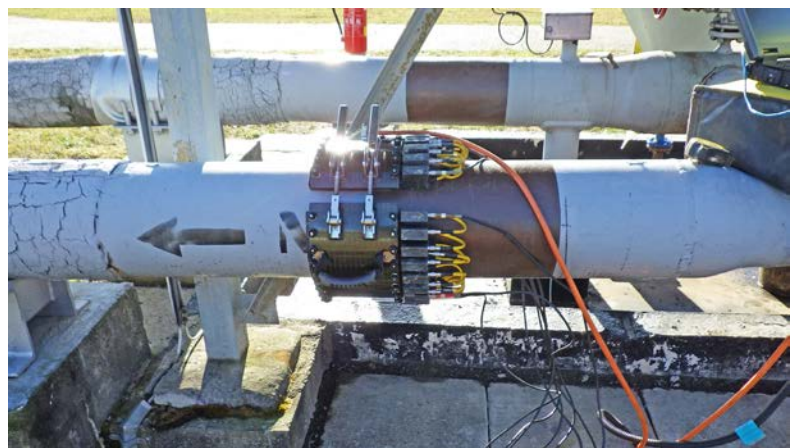
**Figure 5.** LRUT collar with multi-mode modules and transducers sending soundwaves for tens of meters in both directions.

transducer array fixed around the pipe; the technology operates just above audible frequencies. These low frequencies are necessary to enable an appropriate wave mode to travel the surface of the pipe. At these frequencies, a liquid couplant between the transducers and the surface is not necessary; a satisfactory ultrasonic coupling is achieved by pneumatic pressure applied to the back of the transducers to maintain close contact with the pipe surface (Figure 5).

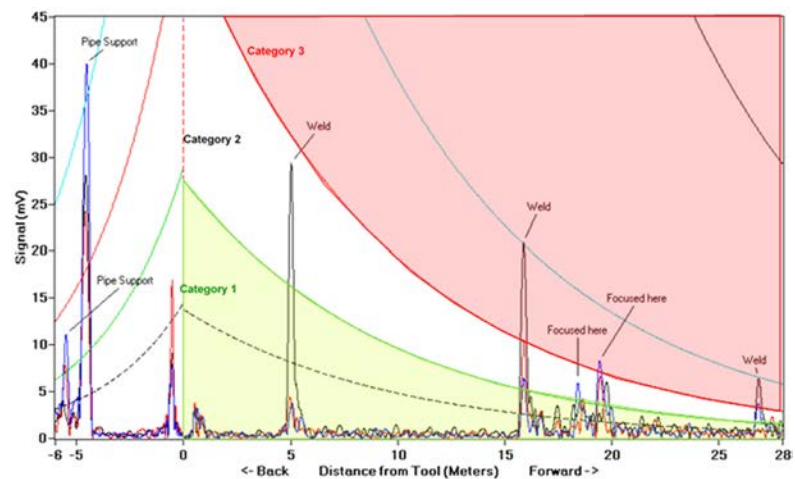
**Figure 6.** Distance amplitude correction (DAC) curve.

Girth welds in the pipe produce dominant signals in the A-scan and act as important markers. Their peak amplitudes are used to set a distance amplitude correction (DAC) curve on the display, and signals from anomalies can be compared to DAC curves (Figure 6).
