Exploring every avenue

Johannes Keuter, ROSEN Germany, details the inspection of an offshore loading line in South America.

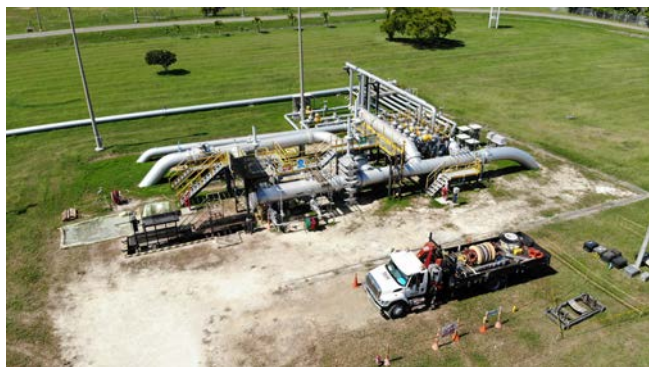
Figure 1. Loading lines only have one launch/receive site, making bidirectional inspection necessary.

ILI of pipelines usually require a launcher and a receiver to insert and remove the tool properly. Loading lines do not have a receiver; instead, they feature a subsea pipeline end manifold (PLEM), making it impossible to launch and receive the inspection tool in the customary way. Instead of a unidirectional inspection, a bidirectional inspection would be required, which would mean

that the inspection tool could be inserted into and removed from the same trap. This specific application requires some specialties in regard to tool design. In this project in South America, more than just a bidirectional inspection was necessary. In order to achieve the highest possible quality in data, the most advanced measurement technologies were chosen.

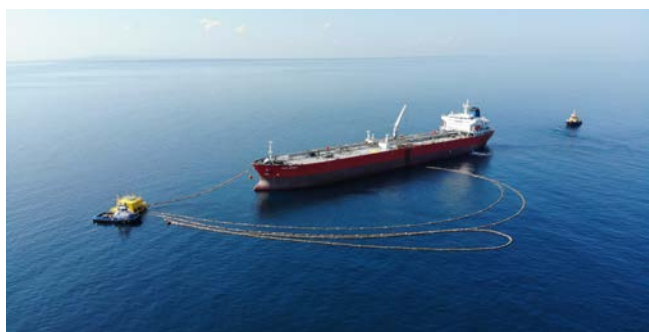
Figure 2. Tool tracking and logistical planning are vital to inspections of loading lines to ensure optimal operation.

The execution of the inspections required round-the-clock work, and therefore an optimal organisation of the on-site team to guarantee success in the given timeframe. The ROSEN team would alternate to have the necessary experts available at all times. The team was divided into multiple locations along the pipeline route. The first group started with the trap area to prepare the cleaning and ILI tools, execute the installation into the trap, and launch the tools. The second was responsible for the tool tracking with electronic pig detectors onshore and offshore, to ensure that the location of all tools was known. The third team – placed on a boat and on the buoy close to the PLEM – monitored the most critical section of the pipeline just before the PLEM. Neither the cleaning tools nor the ILI tools could enter the PLEM. This would cause them to get stuck, because no flow could be provided within the PLEM. They were stopped before that by the accurate determination of the tool location, and the corresponding adjustment of the flow. ROSEN worked closely with the operator and shared the tool location, which allowed the client to adjust the flow accordingly and stop the tools.
