# ASSESSMENT OF COMBINED DEFECTS

A Roadmap to Zero Incidents · Paul Bailes · © ROSEN Group · Paris – France - 28 November-2019

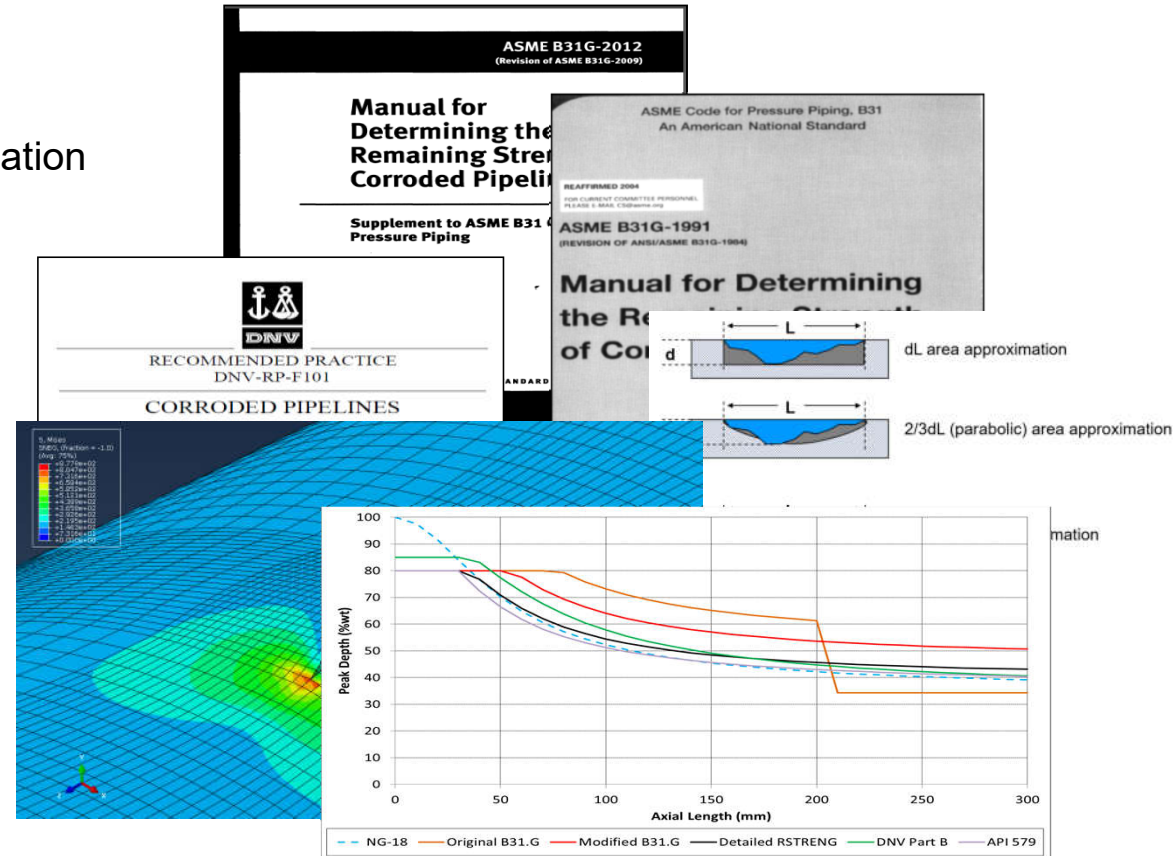
- Predominantly for assessing features in isolation
- Widely used for many years
- Validated through Finite Element Analysis
- Conservatism built into assessments
- Can consider multiple loads (axial, bending etc.)

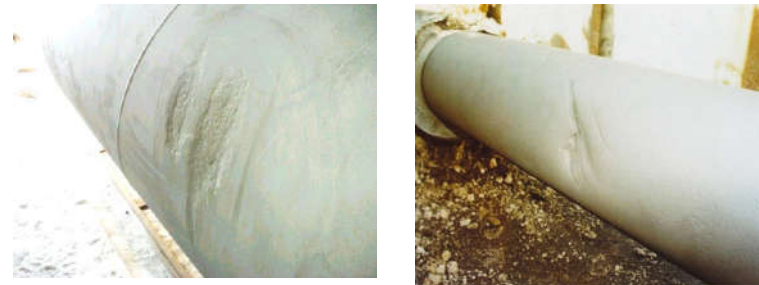
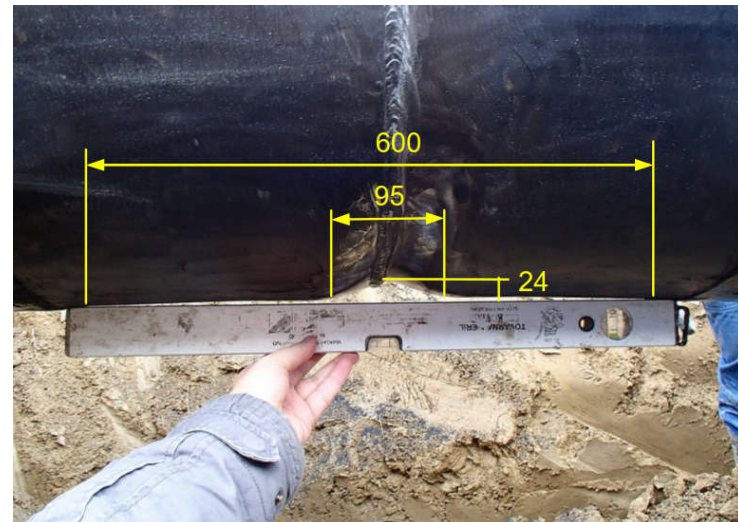
- Limited Codified Guidance
  - Dent with Metal Loss
  - Dent on Weld

- Level 2 Guidance (e.g. API 579) conservative

- Options before detailed FEA?:
  - More detailed inputs (material certificates etc.)
  - Model geometry in (simple) FEA to obtain Stress Concentration Factor (SCF), and use in fracture/fatigue assessments

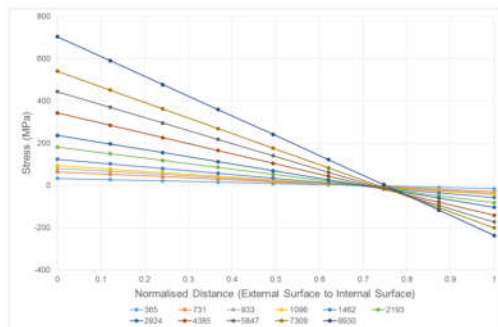
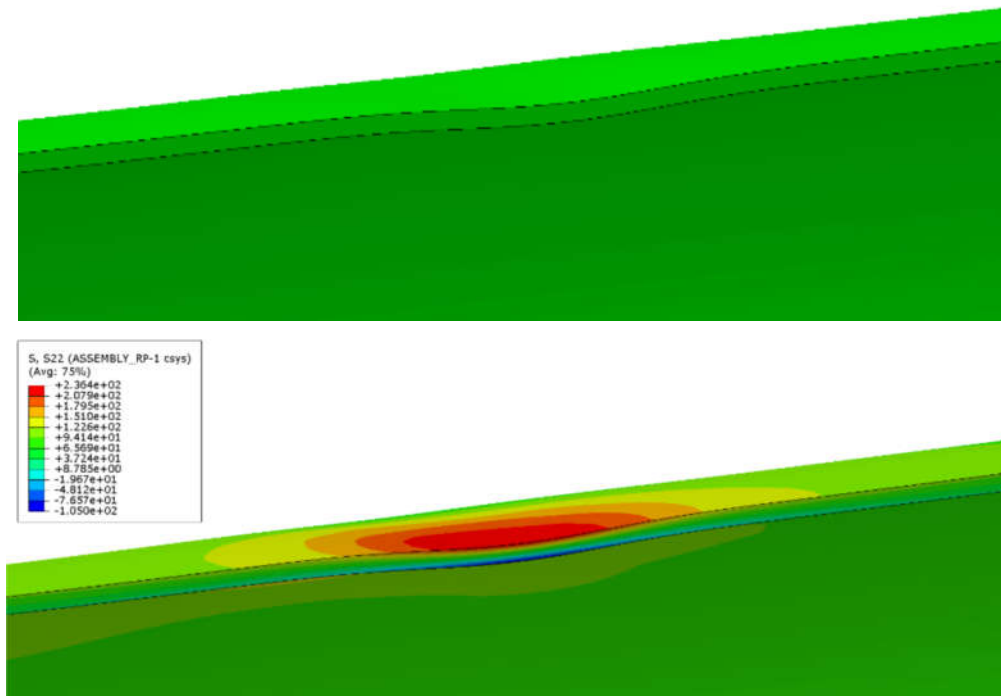
- Dent was modelled using in-field laser scan data
- Significant tensile stresses on external surface
- Compressive stress on internal surface

- Dent on 10 inch oil pipeline
- Verified in-field, small axial crack indications (<1 mm) reported on internal surface
- Time limitations on repair work – 18 months (internal approval required for Type B sleeve)
- Two fatigue assessments performed
  - Fracture mechanics – internal crack fatigue growth
  - S-N curve – crack initiation and growth on external surface

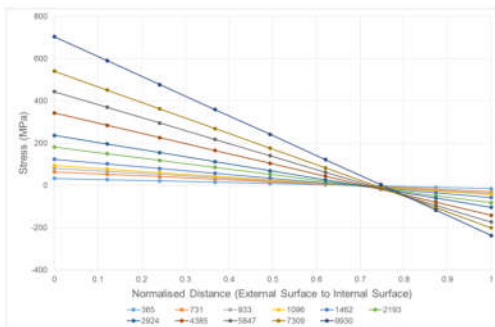
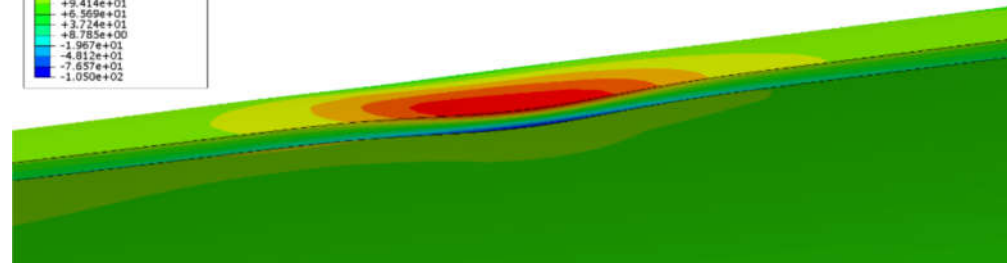
- Dent was modelled using in-field laser scan data
- Significant tensile stresses on external surface
- Compressive stress on internal surface

Fatigue Life (internal crack) > 18 months

Fatigue life (external crack) >50 years

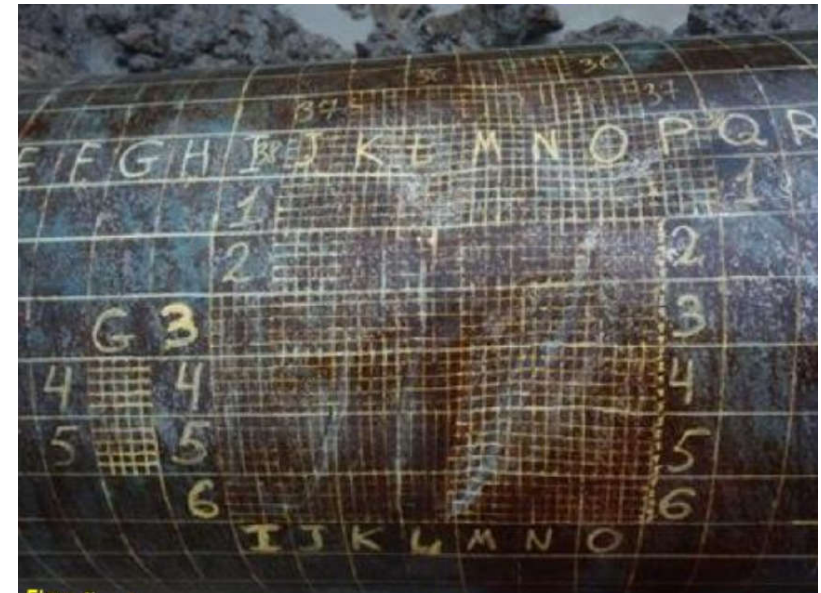
- 24” Oil pipeline operating at 100 bar
- In-field investigation identified dent gouge combination

Unable to weld onto live pipeline – next shut-down opportunity  
> 6 month

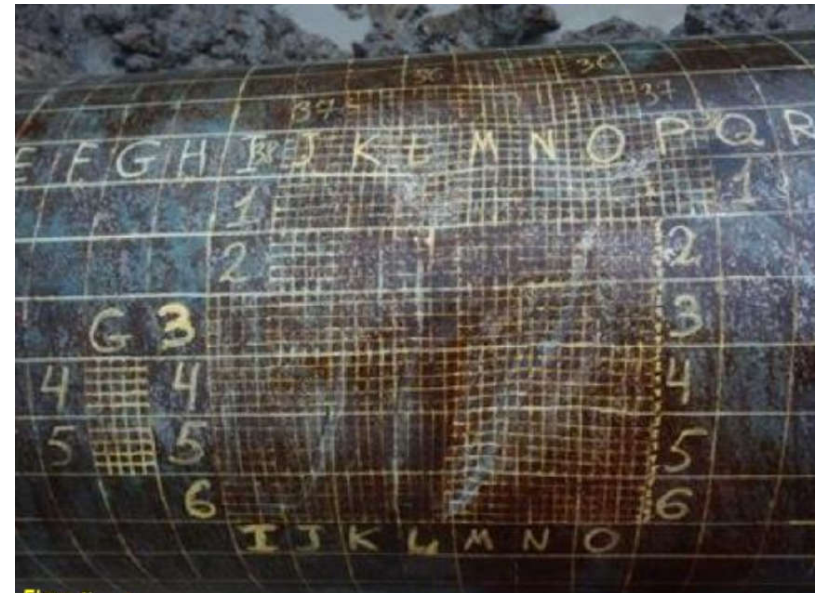
- No Caliper ILI
- Depth based measurements to model dent and gouge
- Account for grinding of gouge (up to 0.7 mm) to remove linear indications

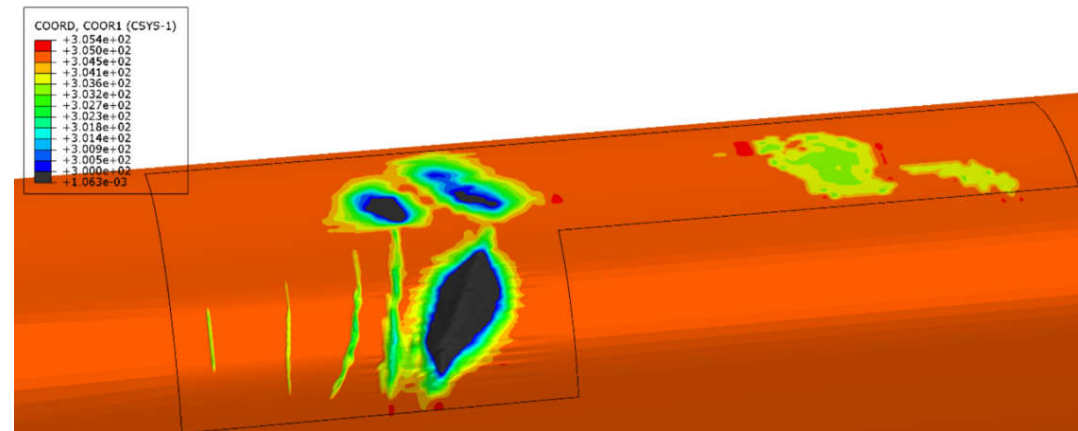
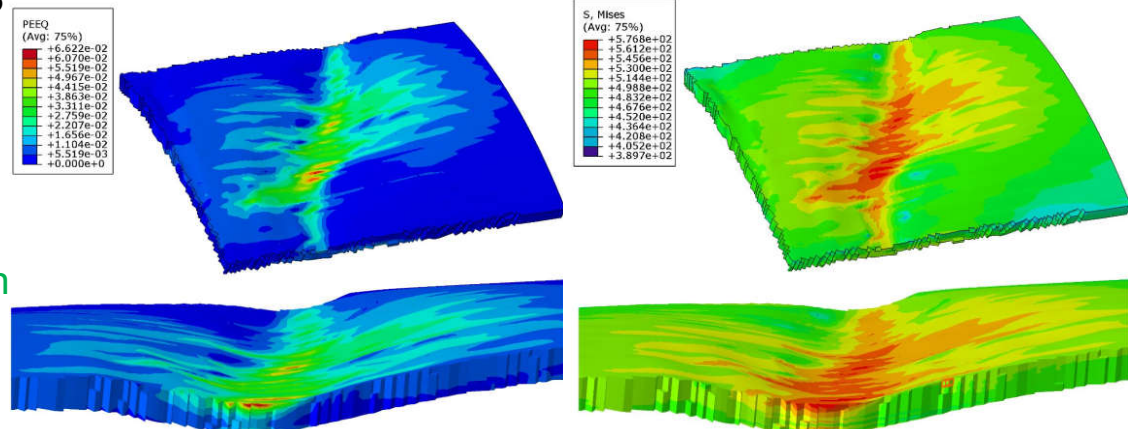
- Dent and gouge modelled in FEA
- Static strength acceptable when considering load  
Safety factor recommended by API 579 of 1.53
- Fatigue life in excess of 50yrs from 2008 construction
- Defect re-coated and backfilled until shut-down was feasible

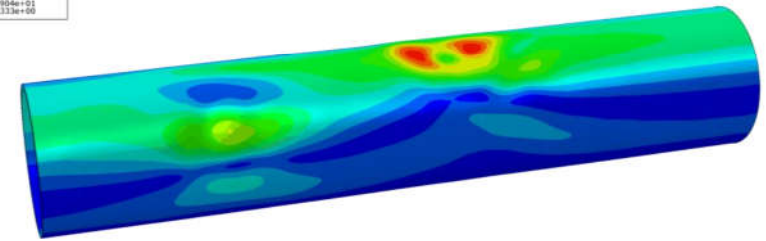
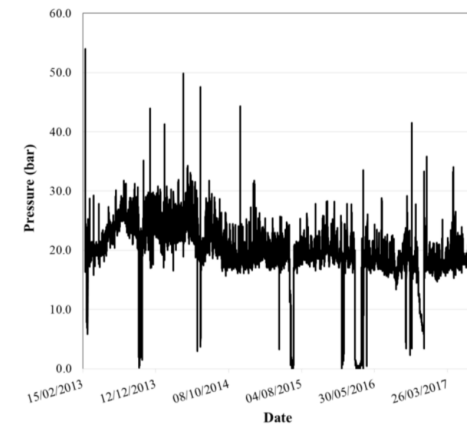
Remaining Life Assessment of 10.2% OD Dent on Subsea Pipeline

- Unacceptable to conventional fatigue assessment
- Pipeline scheduled for decommissioning in 3 years....
- Pressure history indicated a large spike to 54 bar following detection of the dent
- Required bespoke pseudo-hydrotest type assessment

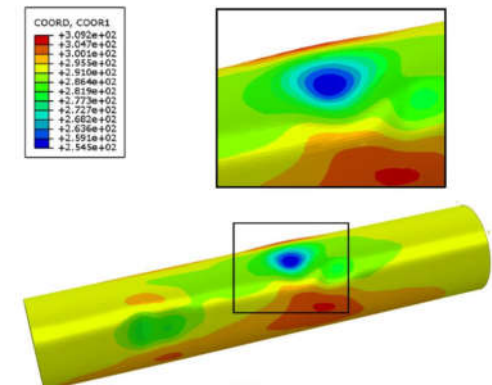
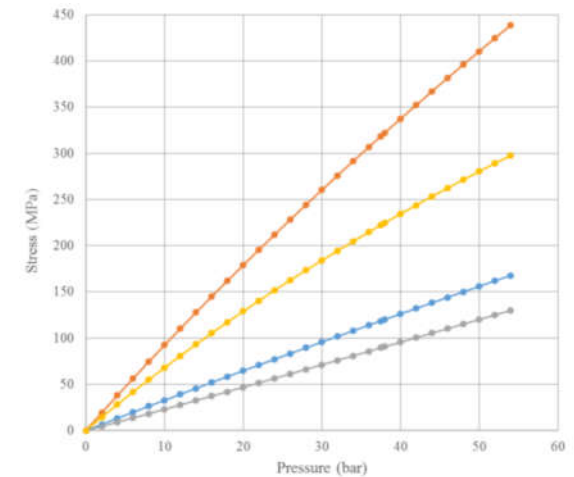
- Dent modelled in FEA to review relationship between internal pressure and the axial and circumferential stresses
- Fracture assessments to determine maximum allowable crack sizes that could have survive 54 bar spike:
  - Semi-elliptical
  - Coincident with highest stress locations
  - Axial and circumferential cracks
  - Aspect ratios

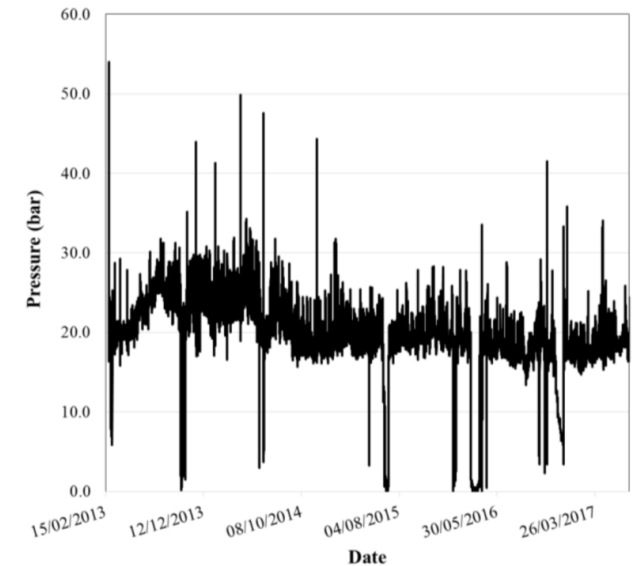
- Pressure data converted to stress cycles to grow the allowable cracks that could have survived pressure spike
  - 54 bar pressure spike

decommissioning date
- Fracture assessments performed at fully grown dimensions – lowest failure pressure defines new Maximum Operating Pressure

Low risk of fracture due to fatigue growth if operating pressure <48 bar

New Maximum Operating Pressure acceptable to operator
