# Tailor-Made for Performance

Solution for Deep Water Offshore Flowlines

# Case Study

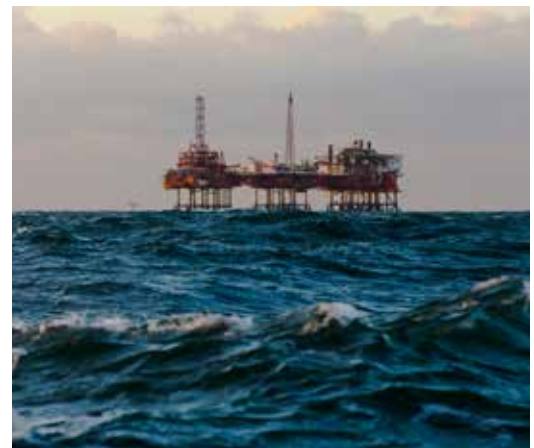
A tailor-made 12" bidirectional (BiDi) UT tool that met the passage and corrosion inspection requirements was developed. The unique design of the BiDi tool ensures that the data quality is equal to that of ROSEN's standard UT tools, thus providing the high-resolution data quality required to ensure the pipeline's integrity. The tool was subjected to pump testing through a simulated pipeline configured to have similar diameters, wall thicknesses, and bend radii as these flowlines.
