Getting to the Bottom of It

The benefits of tank bottom inspection data for the RCA of corrosion

Case Study

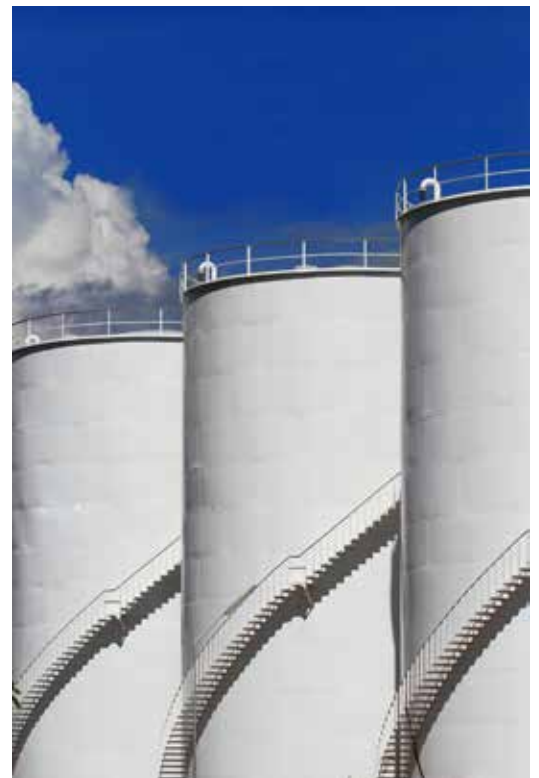
- size (length and width)
- depth (metal loss percentage)
- location (X, Y coordinates)
- discrimination (top versus bottom side)
- C-scan view

It is crucial to gather data of the entire tank bottom, including difficult-to-reach areas, i.e. areas near lap welds and critical zones, such as underneath steam coils and piping, in order to obtain a reliable overview of the overall condition of the tank bottom including any critical defects.
