## Lifelike images of a pipe wall: ROSEN reveals new premium service

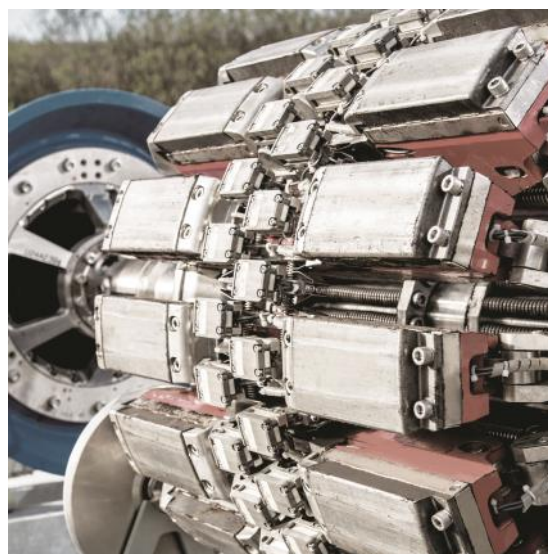
*The highest ILI resolution on the market:  
the new RoCorr MFLA Ultra tool*

ROSEN's RoCorr MFL-A Ultra now addresses both of these challenges: With 1.6 x 1 millimeters, RoCorr MFL-A Ultra features the highest ILI resolution on the market. Full triaxial, ultra-high-definition MFL sensors detect even tiny changes in a pipe wall's structure, displaying what until now has often remained unseen. Unlike other MFL services, it scans the entire internal and external pipe wall. For the adequate assessment of the high-quality data, RoCorr MFL-A Ultra applies AutoData™—machine-learning, adaptive algorithms that are calibrated using high-resolution 3D laser scans of real pipe defects. These algorithms continuously evolve during their application and therefore constantly improve the quality of their results. Within seconds large amounts of data are processed, ensuring that all features are included in the evaluation process and final report.

Just like an MRI scanner provides lifelike images of the interior of the human body, RoCorr MFL-A Ultra produces lifelike images of a pipe wall's structure. The combination of triaxial ultra-high-resolution MFL sensors and an automated data processing application allows for veritable Pipeline Imaging™. RoCorr MFL-A Ultra operates under the same conditions (velocity, bend passage, temperature, pressure) as common MFL services. Moreover, the dual layer sensor design delivers both high- and ultra-high-resolution data in one run, providing a seamless connection to previous inspection data for corrosion growth assessments.
